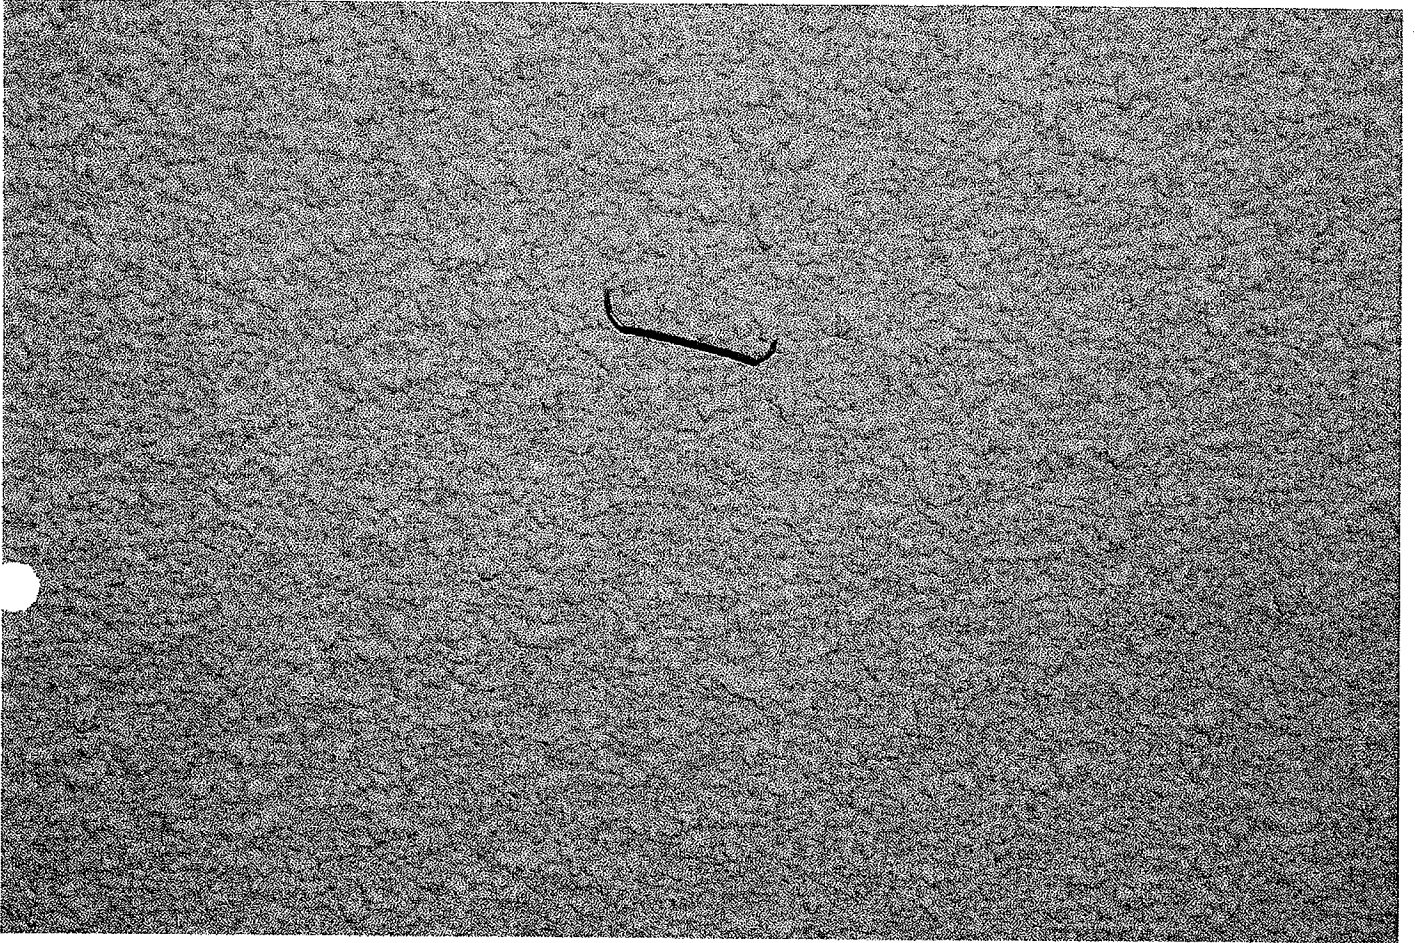
16. 19th floor, elevator lobby - center - View of fastener placed into accoustical spray finish

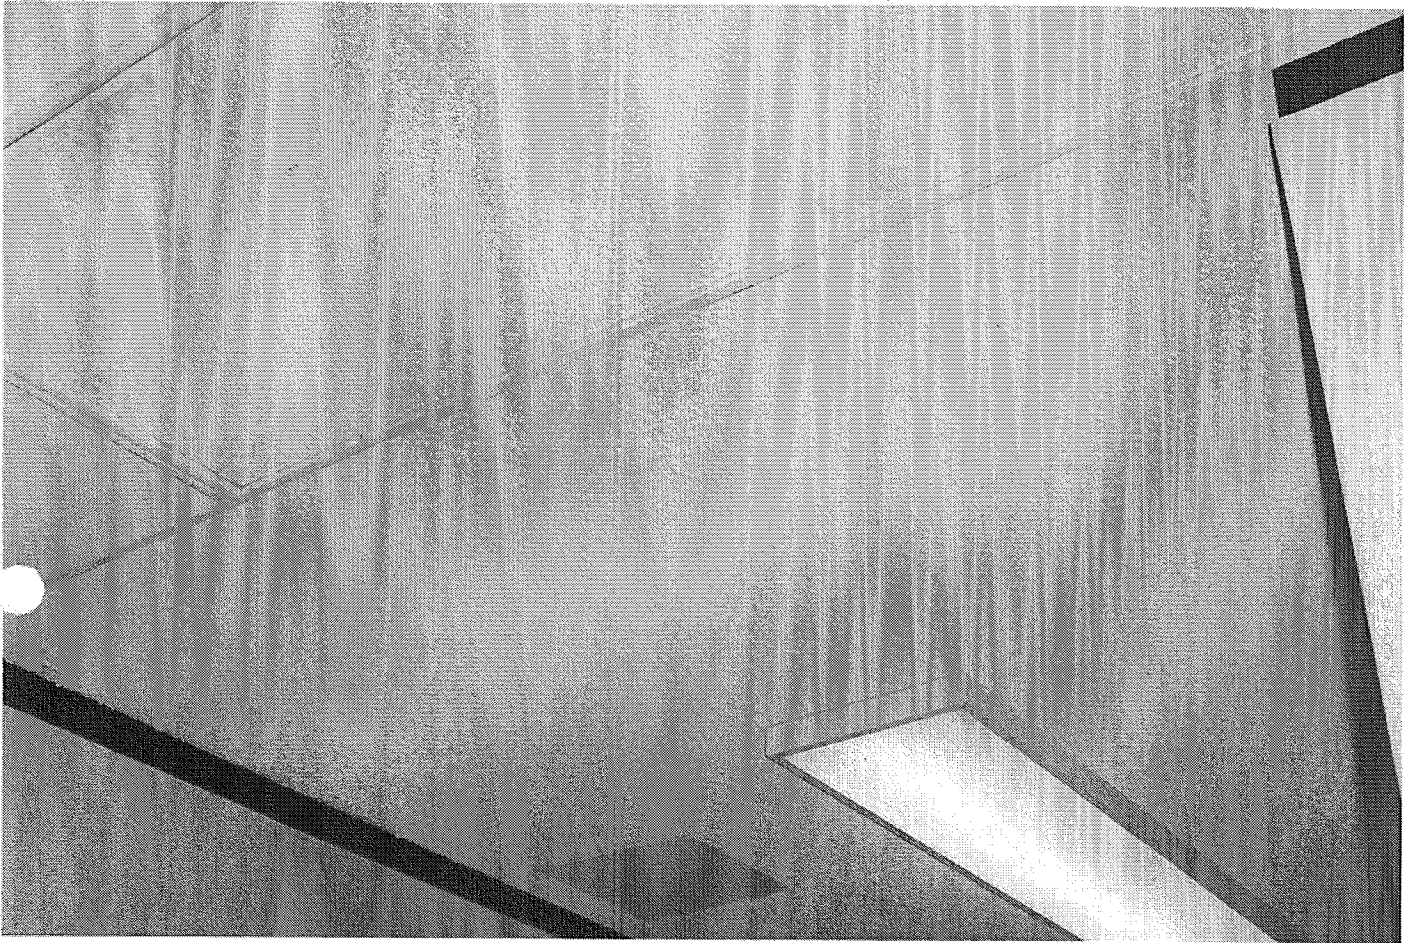
17. 3rd floor, elevator lobby - south hallway - View of waterdamaged acoustical spray finish

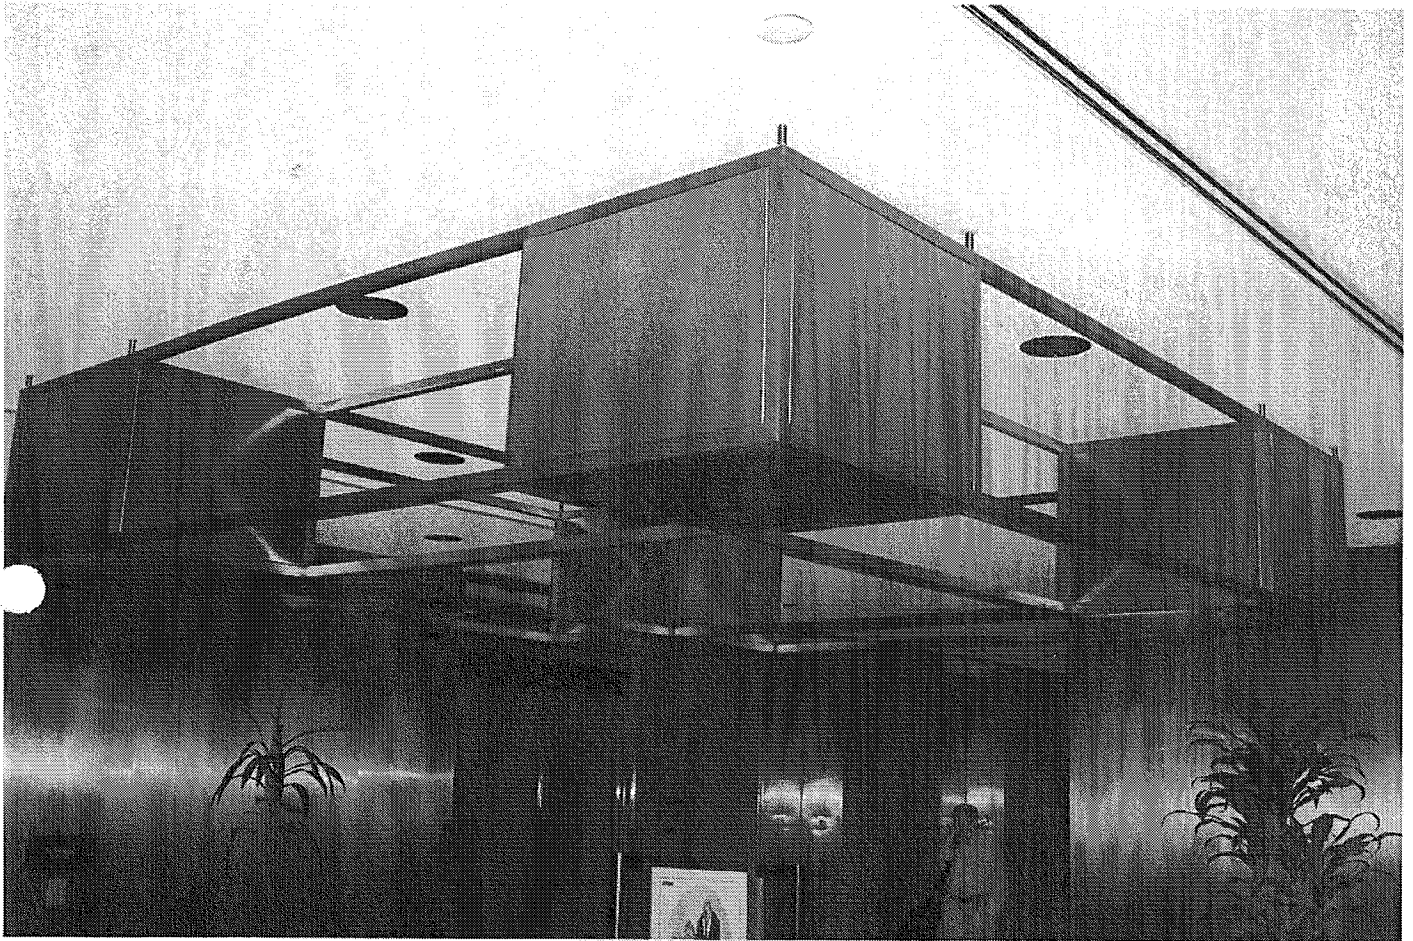
18. Basement, subteranean corridors - View of ornamental fixture attached to acoustical sprayed ceiling

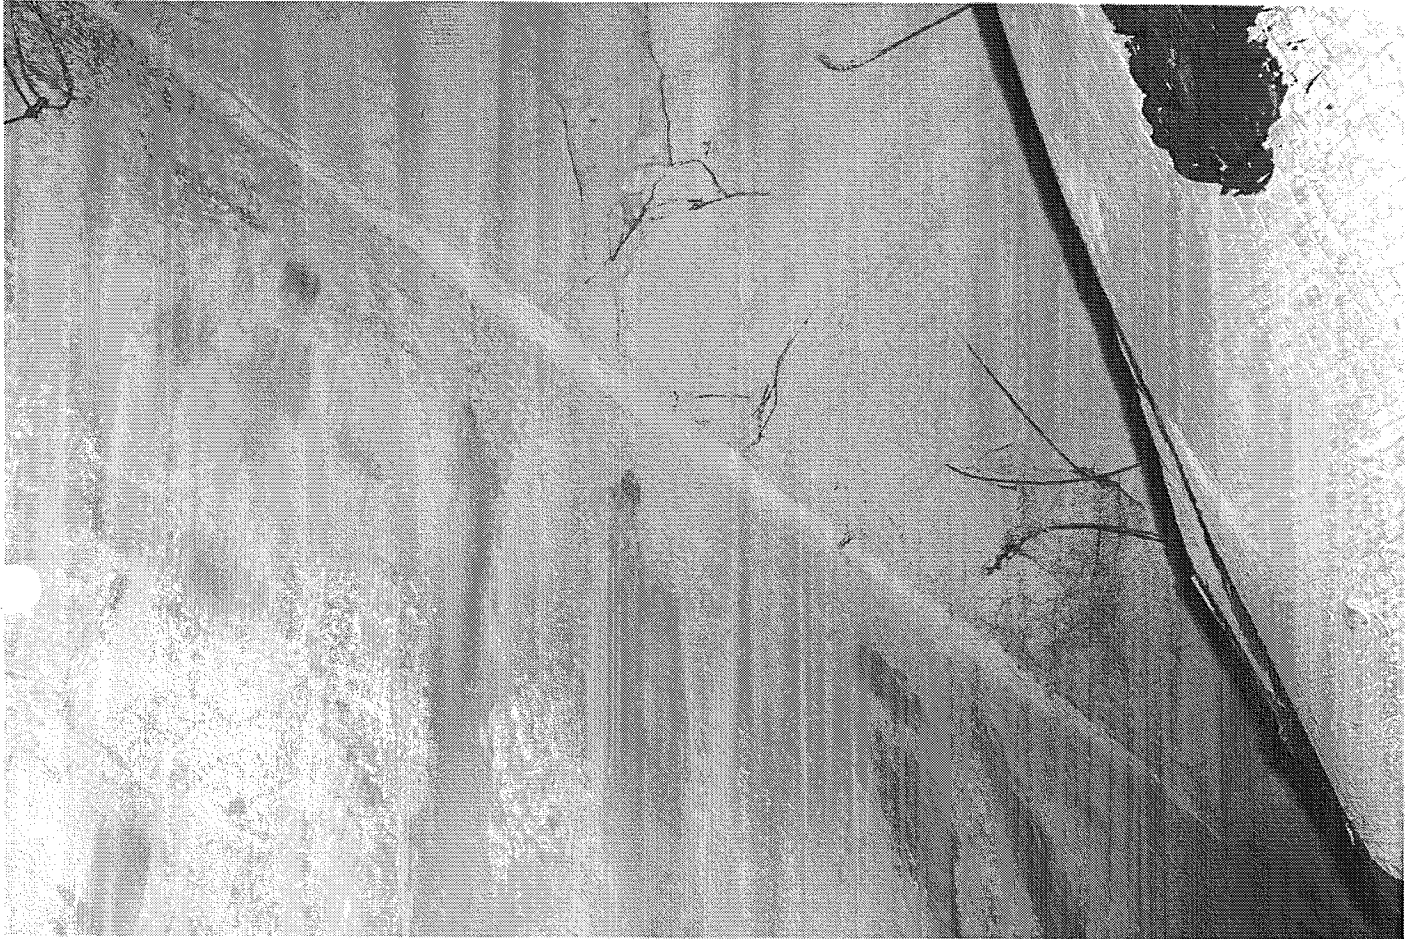
19. 1st floor, SW mechanical room - View of exposed fireproofed sprayed decking

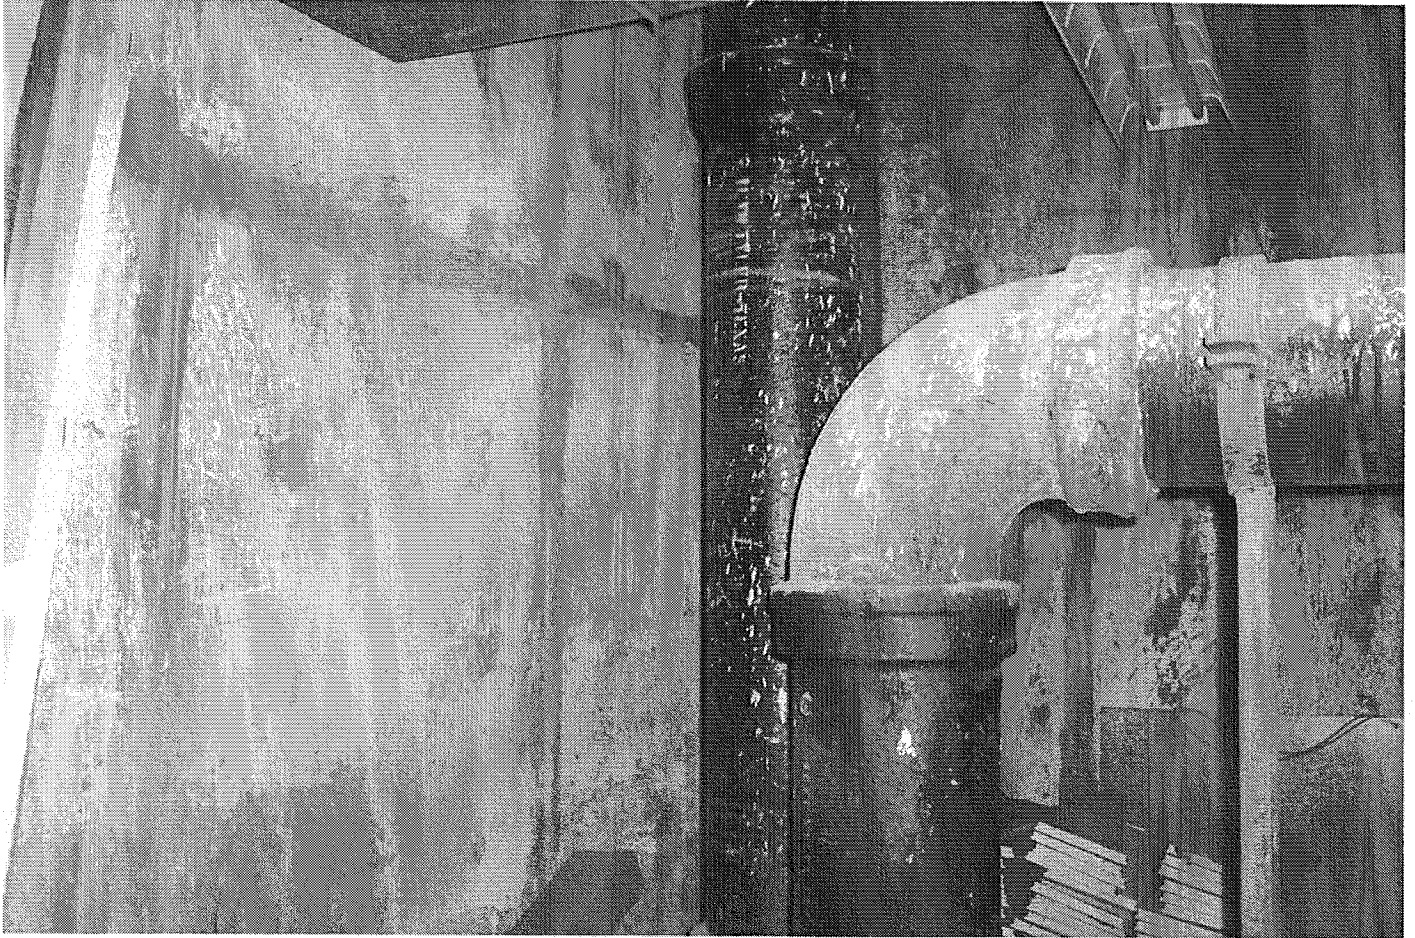
20. 1st floor, SW mechanical room - View of dislodged fireproofing debris on pipe
